Clinical Case Report

Case History – Revision of Failed Total Ankle Replacement to Fusion with Meshworks Cage.

Sheffield Teaching Hospitals NHS Trust

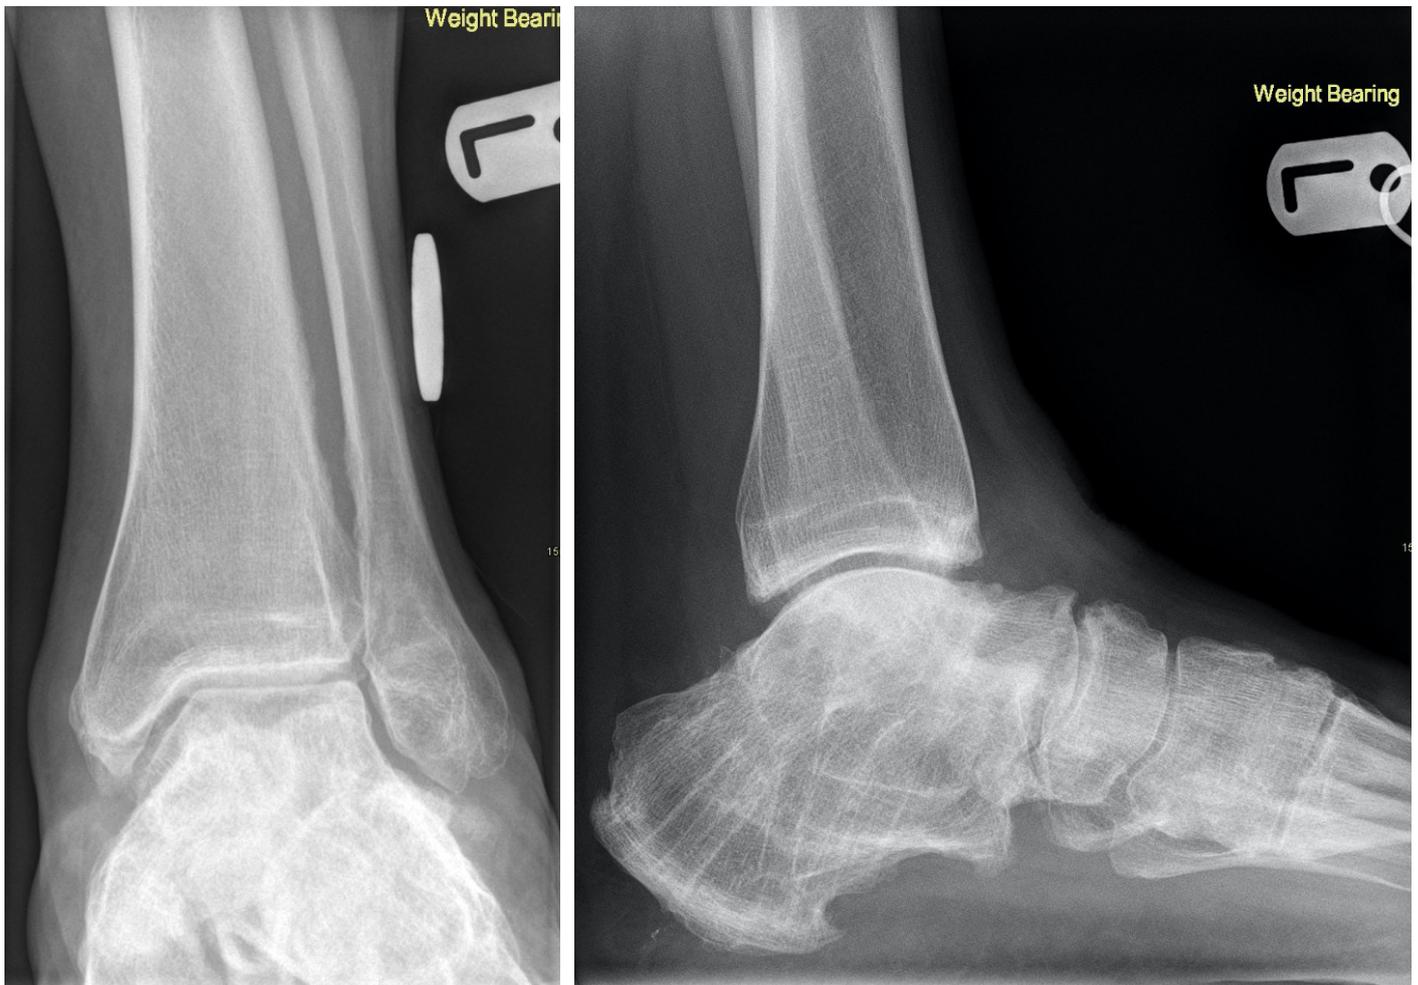
She had a significant history having sustained a closed left calcaneal fracture in 2012 which was treated by open reduction and internal fixation that had become infected. After removal of metalwork, she underwent a subtalar fusion owing to ongoing pain. This failed to unite and so, in 2016, a further attempt at fusing this joint was undertaken achieving union with no further history of infection. However, since this surgery, she had persistent pain around the hindfoot which differed in its character from the pain prior to the subtalar fusion. Examination revealed a quiescent soft tissue envelope and well healed surgical scars. Tenderness was elicited around the ankle joint line. Radiographs revealed early arthrosis within the ankle joint (Figure 1).

Figure 1 - AP and lateral plain radiographs

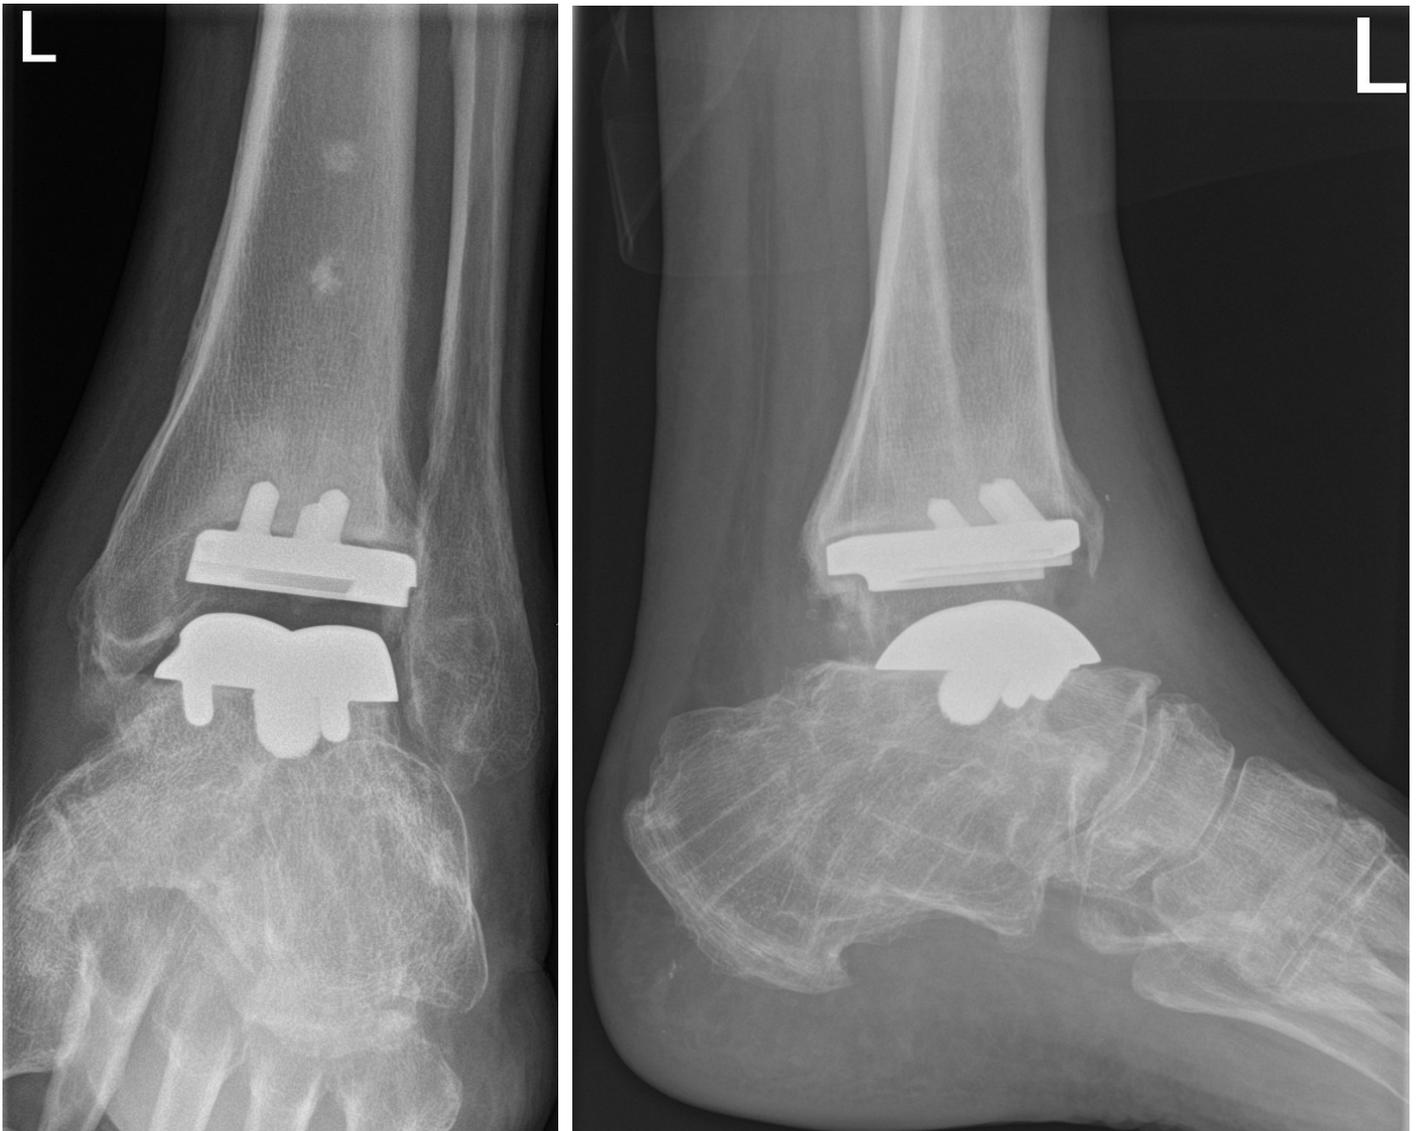
Figure 2 - Plain films post total ankle replacement

Unfortunately, six months after the TAR surgery, the patient remained in a great deal of pain with persistent swelling. There had been no history of wound issues. Plain radiographs did not provide a clear reason for these symptoms but there was some concern on a postoperative CT scan that the tibial component was showing early signs of loosening, raising the possibility of an indolent bacterial infection. Aspiration of the TAR did not reveal any organisms and a year after TAR implantation, given the severity of symptoms, plans were made to remove the TAR and treat for an undiagnosed deep infection. The TAR was removed and a gentamicin-impregnated cement spacer was inserted into the void.

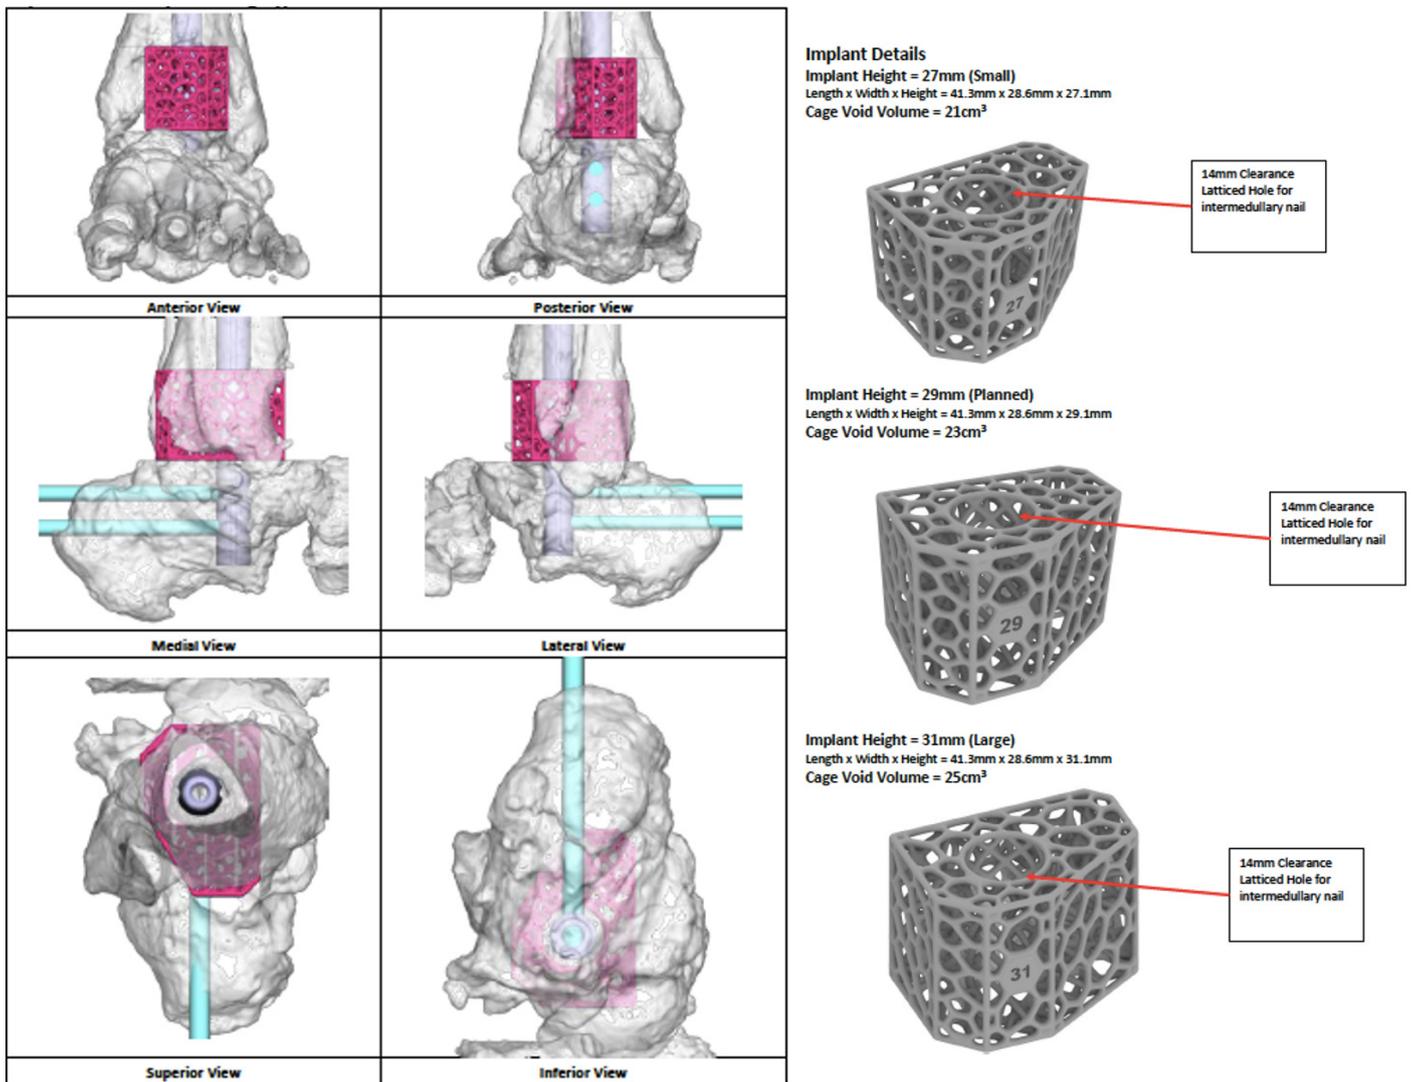
With the TAR explanted, the soft tissues healed well and some of the patient's pain was alleviated. No growth of organisms was identified from the intra-operative samples. The patient was keen to pursue further surgery to achieve greater pain relief and plans were made to convert the pseudarthrosis to an arthrodesis using a custom cage to fill the void. CT imaging was used to delineate the extent of the bone void and this was used to devise a surgical treatment plan (Figure 3). Through the previously utilised anterior approach to the ankle, a custom cage was designed with a central cannulation to secure it with the Oxbridge hindfoot nail. It was intended to fill the cage with bone graft and Cerement G to cover for any possible residual deep infection.

Figure 3 - the planned cage implant and Oxbridge hindfoot nail

The implant was designed to be implanted utilising the previous anterior approach for implantation and explantation of the TAR. The cement spacer was removed piecemeal and samples were taken for microbiological assessment.

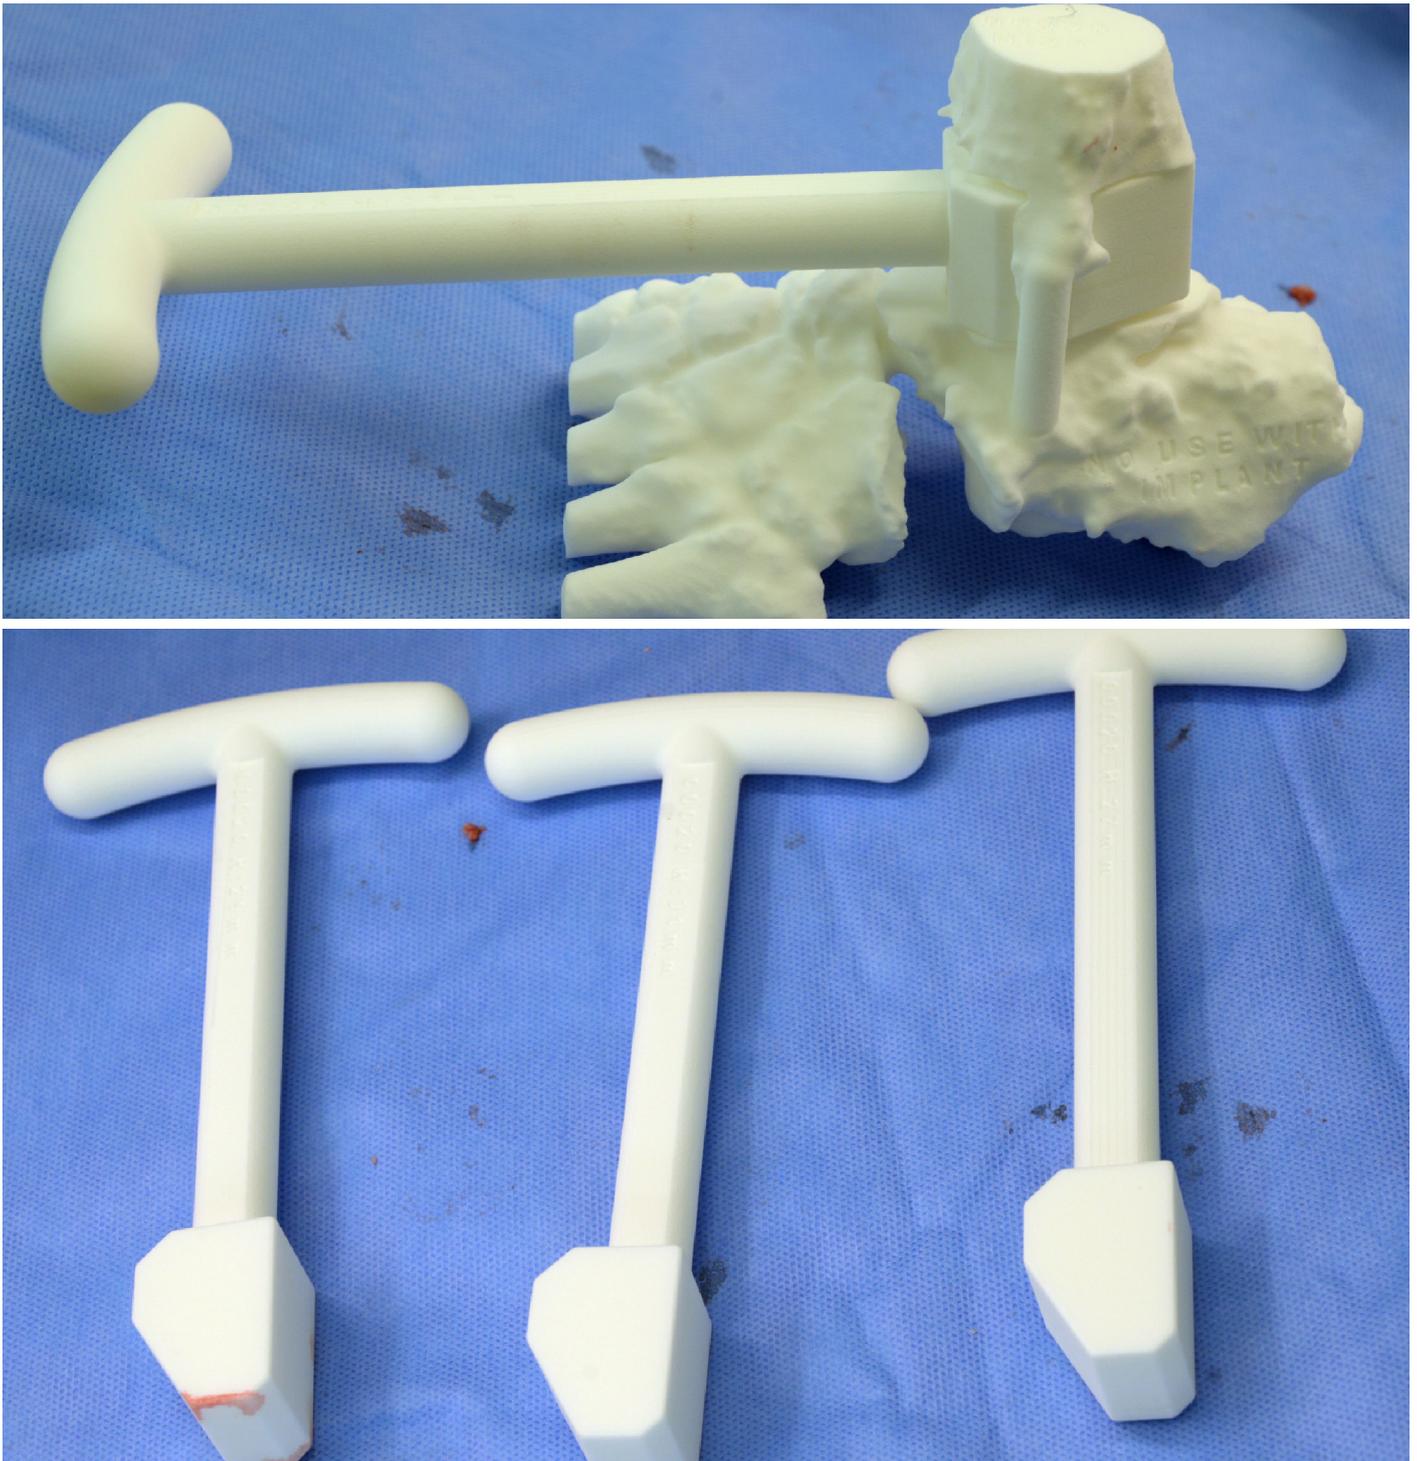
In order to prepare the void, an intra-operative plastic model was used as a guide to cut fresh flat surfaces to the tibia and talus (in retrospect, the use of custom saw guides would have improved this step). Once prepared the void was then assessed using the plastic sizing jigs to

Figure 4 - the plastic model of the void in the foot together with the plastic implant trials.

find the best fit checking to maintain a plantigrade foot (Figures 4 & 5). Once the appropriate size was established, the implant was filled with bone graft and placed in a custom plastic mould to facilitate the application of the Cerement G® [Bonesupport, Lund, Sweden] to the cage (Figure 6). Its changing viscosity can make it difficult to handle and prevent it leaking out of the implant. Once the implant was prepared, it was then placed into the void and secured with the Oxbridge hindfoot arthrodesis nail. The nail was inserted and locked dynamically in the tibia and statically in the calcaneus.

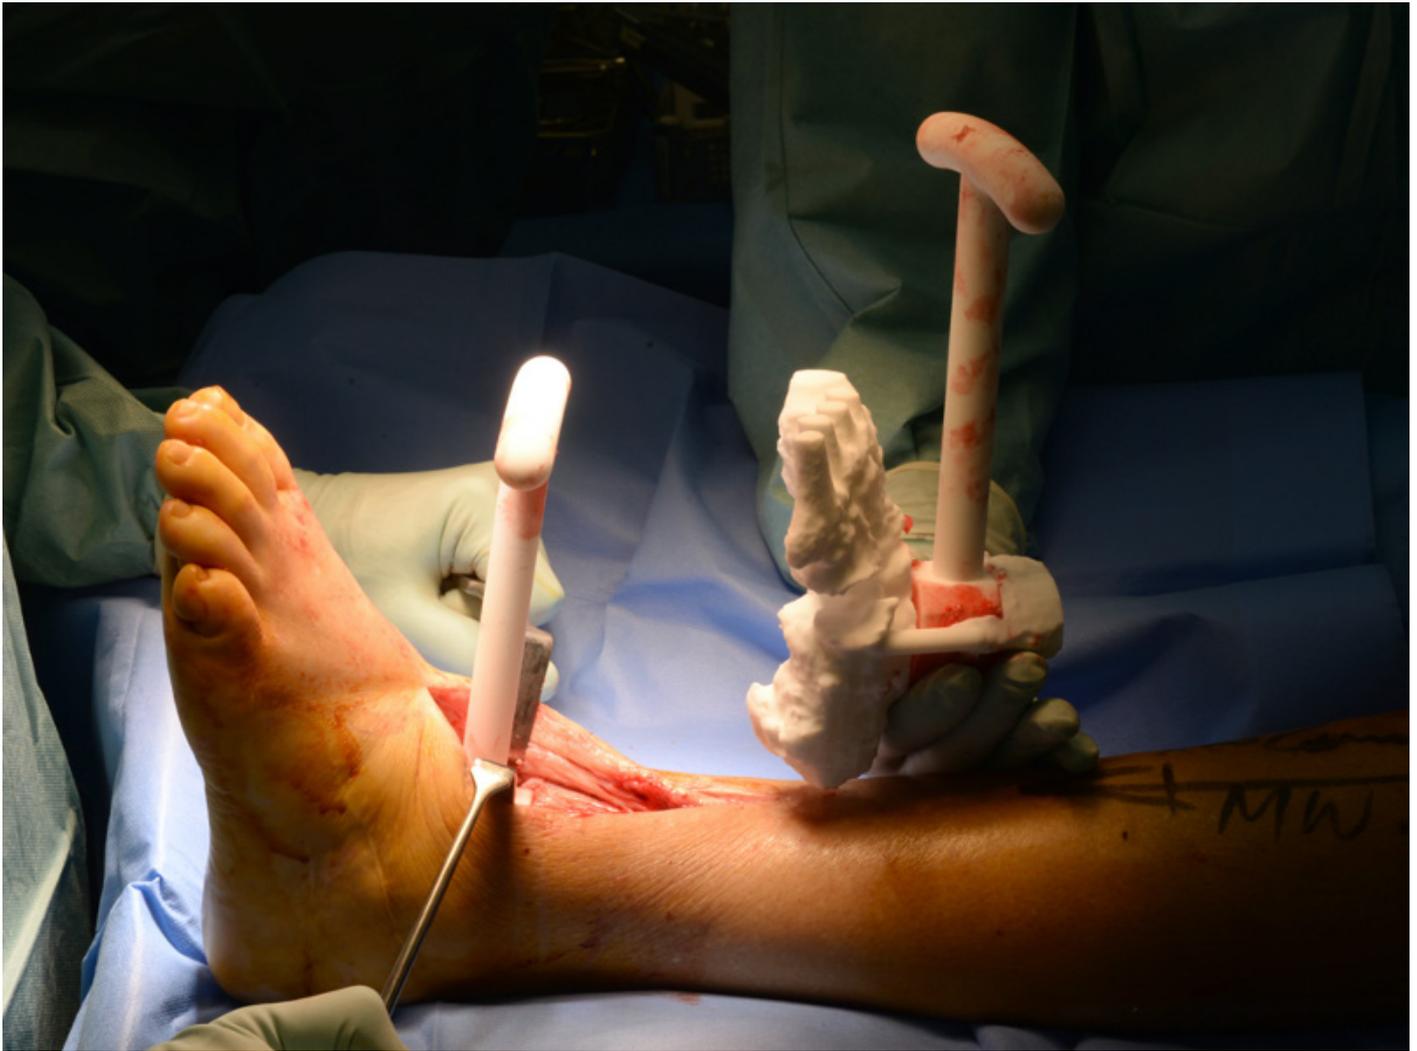
Figure 5 - The models and trials in use

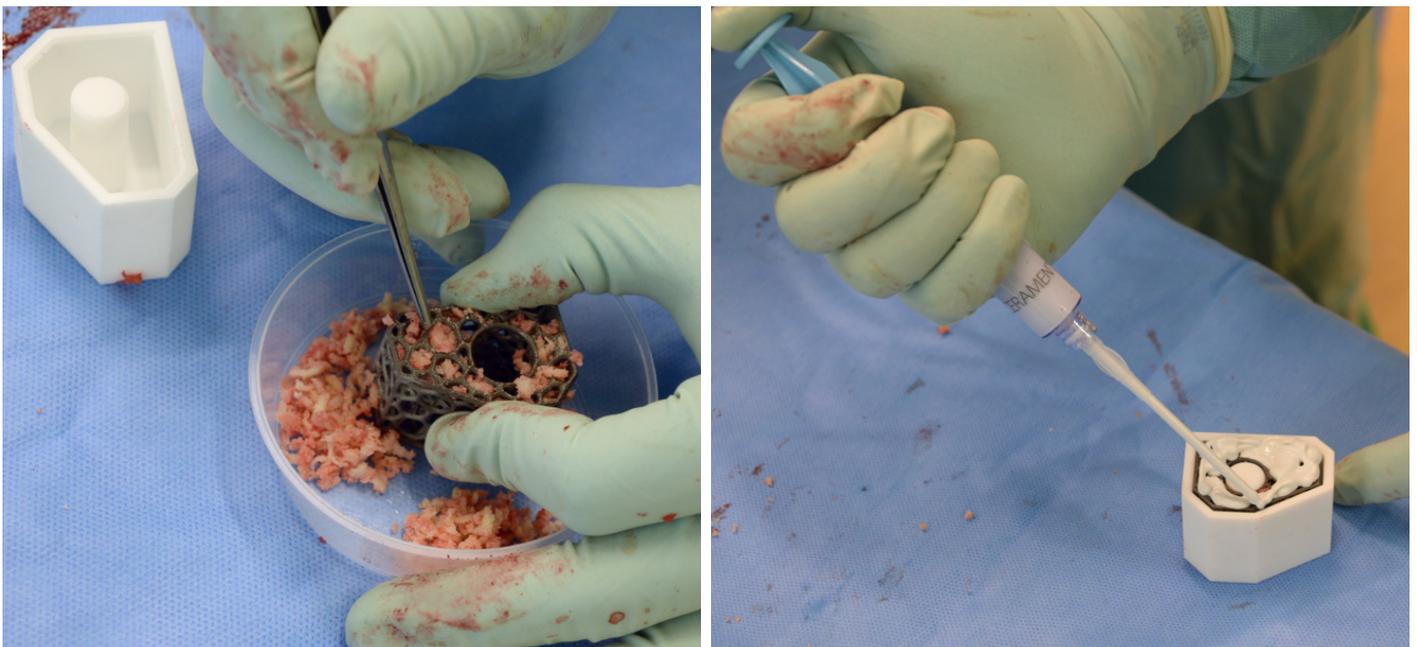
Figure 6 – packing the implant with bone graft and then further filling the interstices with Cerement G® [Bonesupport, Lund, Sweden]

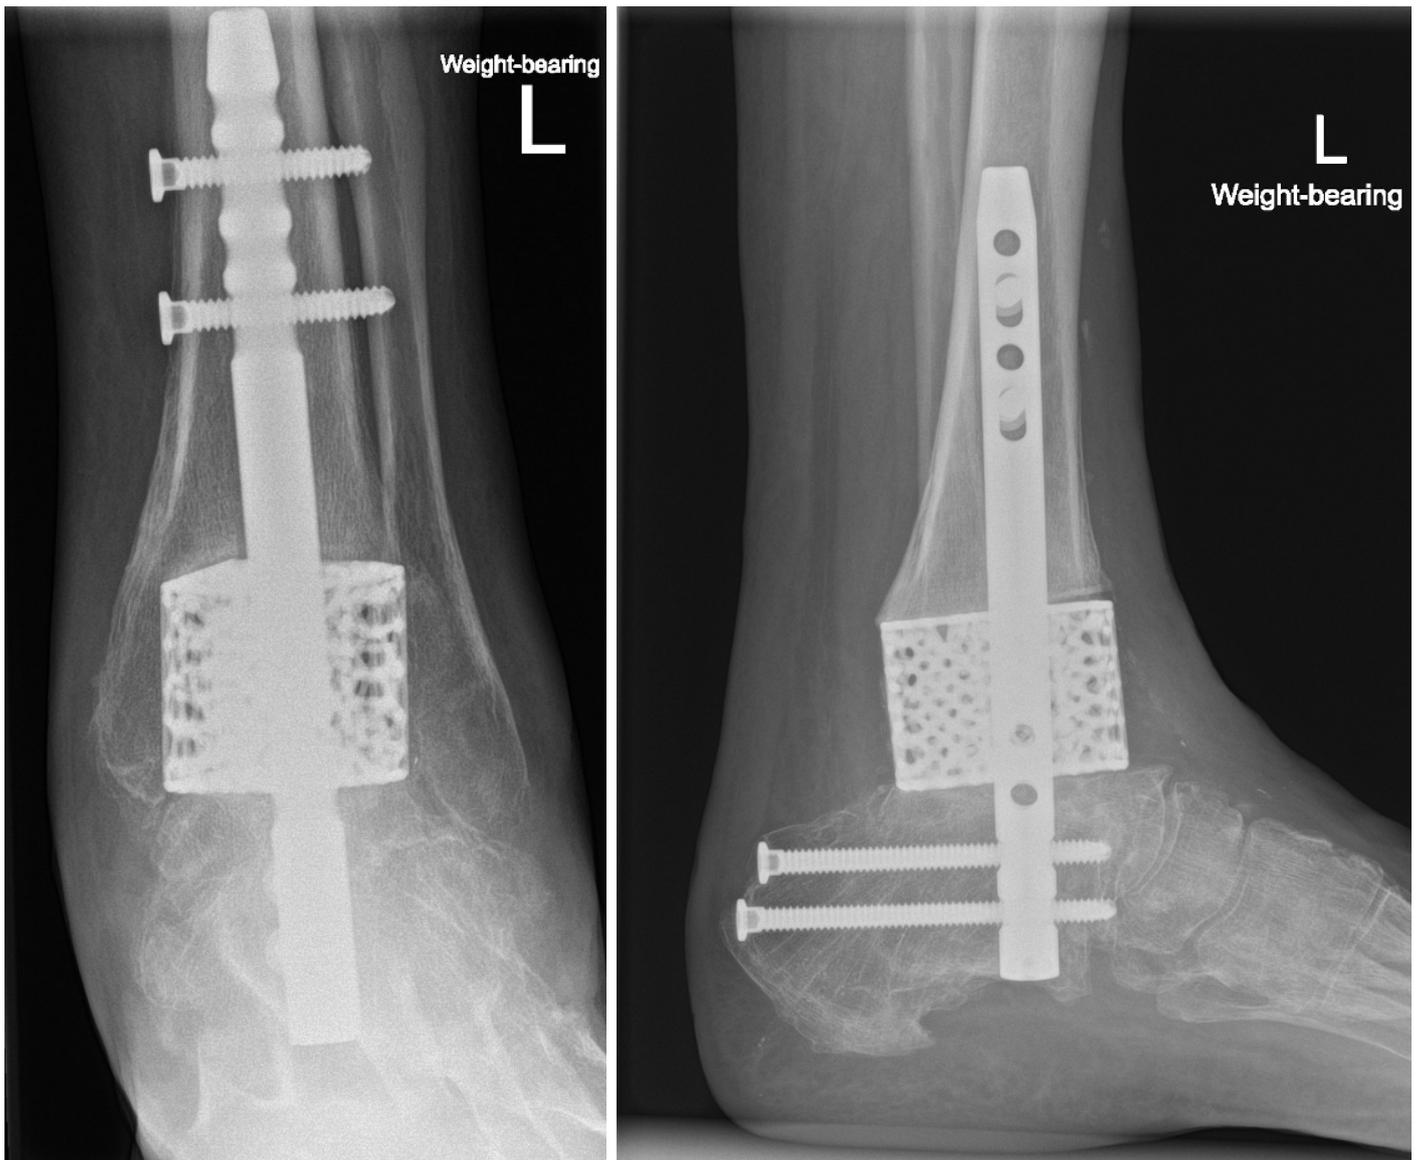
Post-operatively, the leg was rested in a cast for 6 weeks without permitting any weight-bearing. Appropriate thromboprophylaxis was administered during this time. The wounds were checked at 2 weeks and at 6 weeks the patient was allowed to commence bearing weight in a walking boot. The patient was seen in clinic with regular clinical and radiographic assessments. At 6 months of follow-up, the patient has experienced almost 50% of pain relief and improved function as measured by her MOX-FQ scores. She has some residual pain after long periods of bearing weight and on uneven terrain but is the most comfortable she has felt in years. Latest radiographs simply shown that the hindfoot remains well aligned (Figure 7).

Figure 7 - AP and lateral weightbearing views of the implant at 6 months post-op
